Case-study based analysis of the success of good practice and mitigation of  
landscape impacts of tracks in the Scottish uplands.

A report for Scottish Natural Heritage.

Supervised by Dr. Elsa João • The University of Strathclyde • April 2019

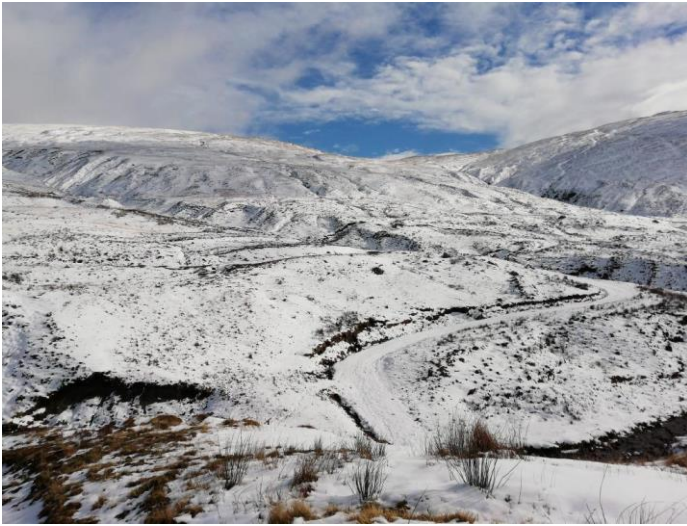
Figure 3. Gleann Casaig: from the footpath facing northeast towards the loop track; viewpoint 27

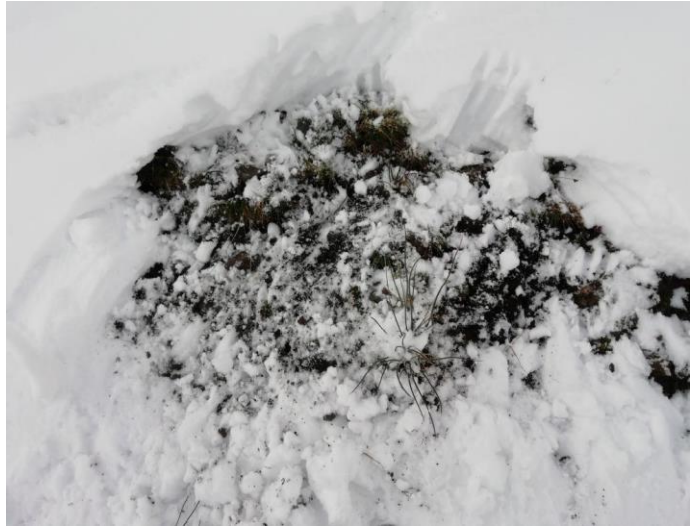
Figure 4. Gleann Casaig: signs of revegetation of new track extension batters; viewpoint 17

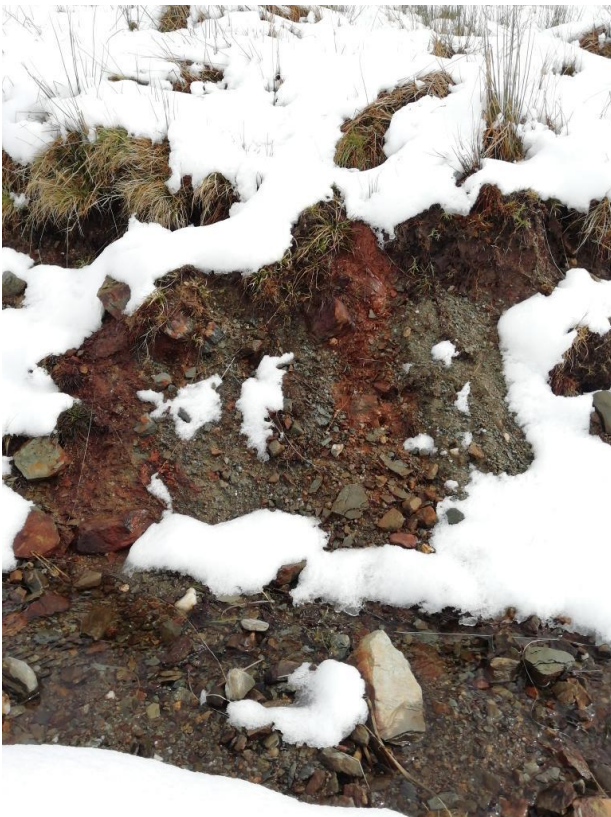
Figure 5. Gleann Casaig: signs of poor revegetation and erosion of new track slopes; viewpoint 20

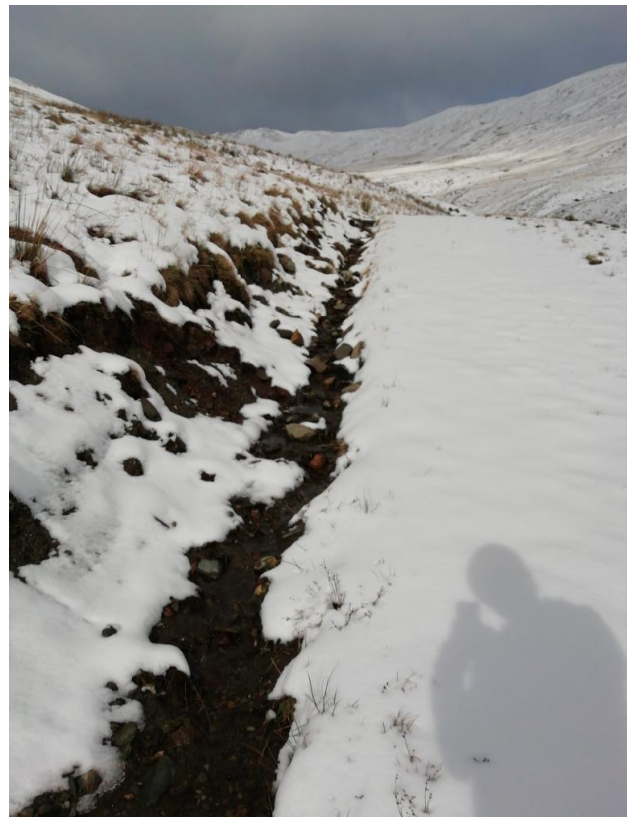
Figure 6. Gleann Casaig: signs of vegetation along the new track side and mid-verge; facing south; viewpoint 20

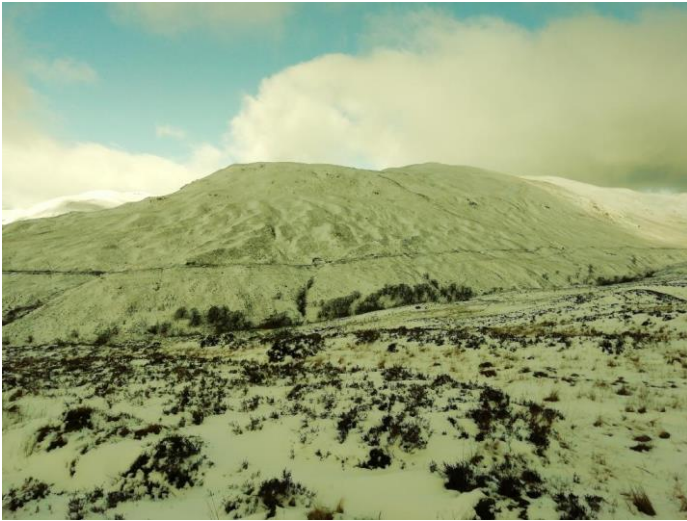
Figure 7. Gleann Casaig: from the existing track facing west towards the pipeline and accompanying footpath; viewpoint 8

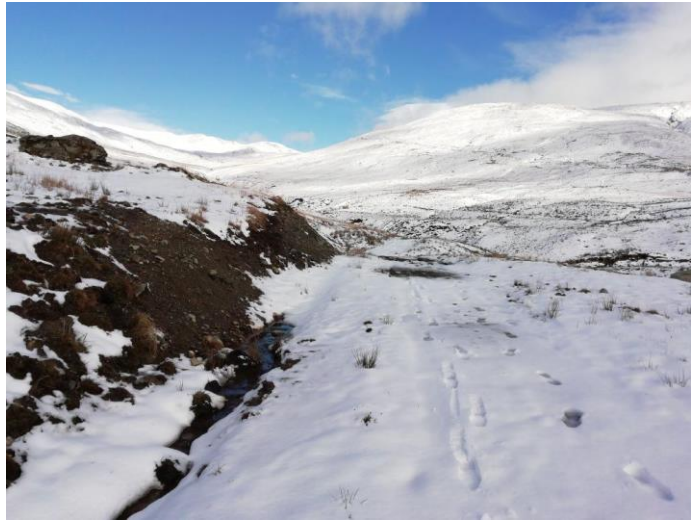
- The footpath's batters were extremely steep at times, occasionally for long stretches, with sparse pockets of vegetation and signs of erosion (Figure 8). The exposed soil resulted in landscape scarring that was previously observed while walking along the existing track from the opposite side of the gully (viewpoints 8-9, 14, 25).

Figure 8. Gleann Casaig: mixed signs of revegetation on steep footpath slopes; facing north, viewpoint 29

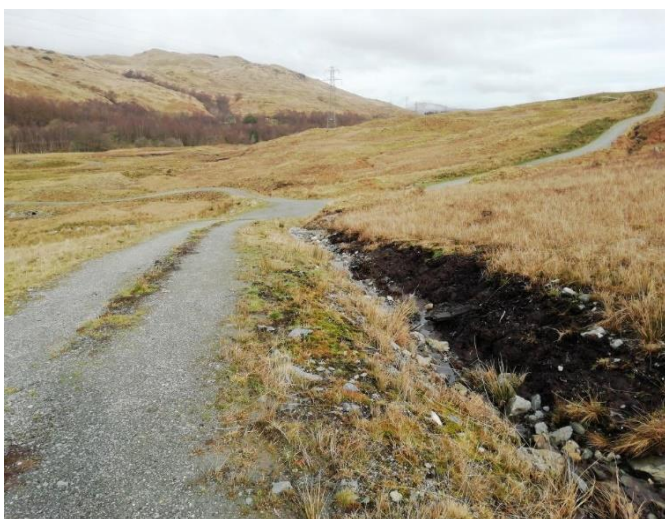
- Tracks were collectively visible throughout the area. In addition, powerlines and pylons, the cottage and the A82 road (although mostly shielded by trees, the noise from traffic was always audible; it is unknown if frequency of traffic is more or less on weekdays) contributed to landscape encroachment (Figures 10 and 13).

Figure 10. Derrydarroch: exposed soil on intake 4's track. Facing northwest towards existing tracks with the track for intake 2 visible in the distance; viewpoint 4

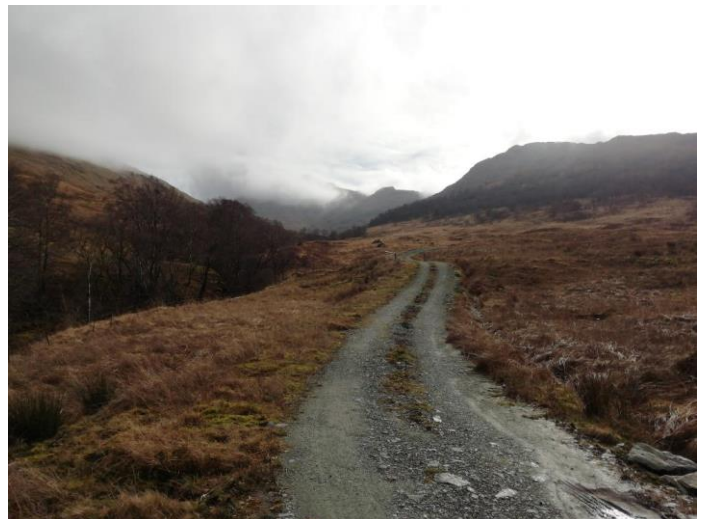
Figure 11. Derrydarroch: central verge vegetating along intake 4's track. Facing southeast towards the intake, the track neatly keeps to landform; 15 viewpoint 8

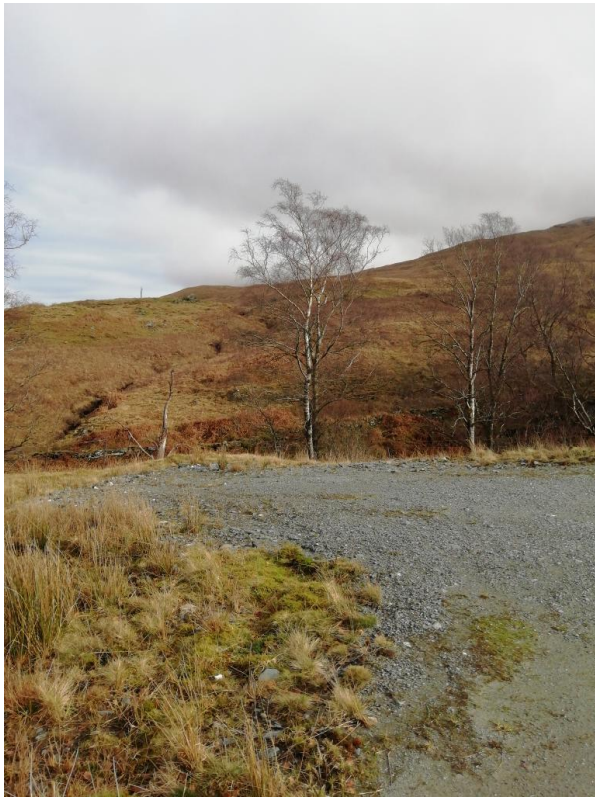
Figure 12. Derrydarroch: a passing place widens the track to intake 4; viewpoint 9

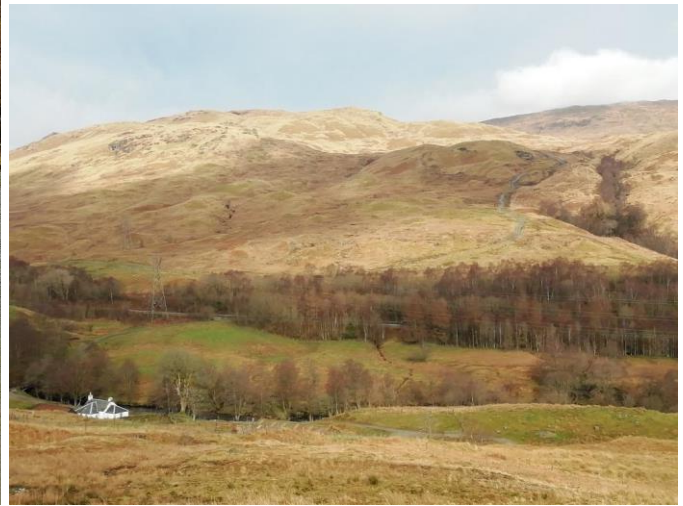
Figure 13. Derrydarroch: facing westerly, intake 2's track is visible from intake 3's existing track; viewpoint 12

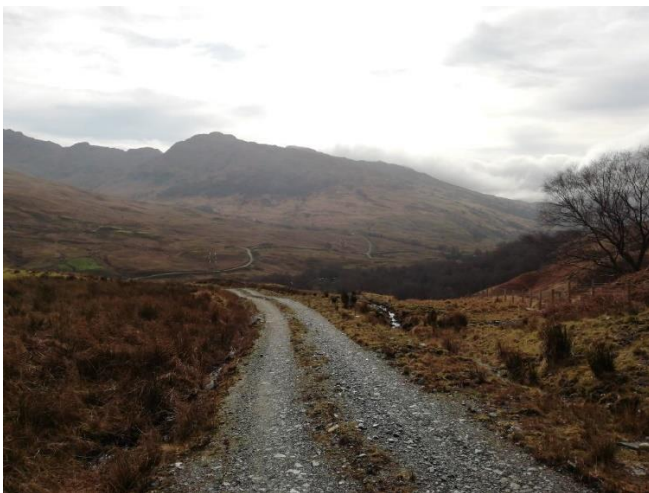
Figure 14. Derrydarroch: from intake 2's track and facing southeast, existing and new tracks are visible for intakes 3 and 4; viewpoint 15

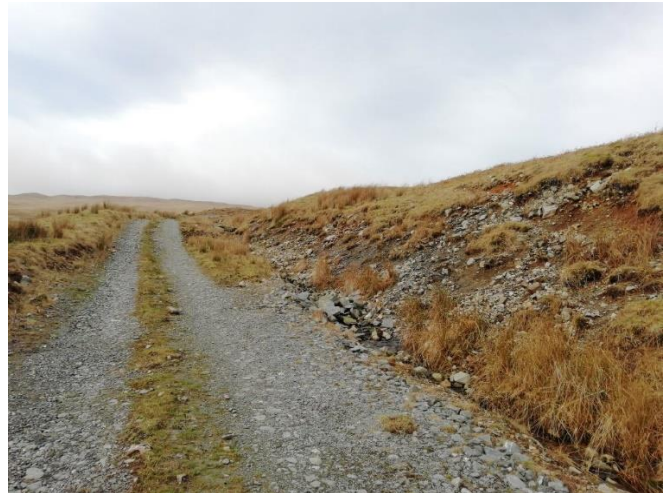
- Near the beginning of intake 2's track, batters were steeper to one side of the track (Figure 15). Vegetation was in pockets and signs of erosion were evident, resulting in localised landscape scarring and widening of the track's overall impact. This was uncharacteristic of the track.

Figure 15. Derrydarroch: central verge well vegetated. To the right, the slope is visibly scarred and vegetation is pocketed; viewpoint 23

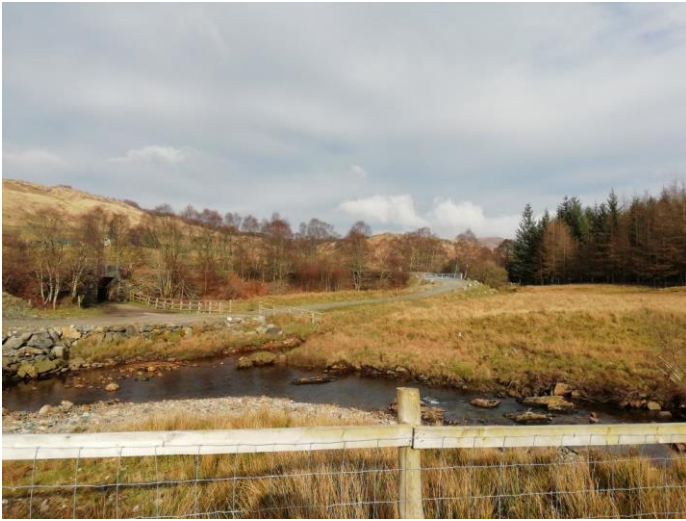
- This particular section of the new track had a central vegetation strip developing albeit intermittently. It was fenced off from the existing track and railway line (Figures 17 and 18). Walkers were not observed to be using the track, opting instead to use the pathway under the railway line. The looped track immediately next to the tree line was non-existent. (A locked gate by the railway restricted vehicle access. Due to time restraints, the upper track extension near the intake was unable to be viewed.)

Figure 17. Upper Falloch: view of the track extension; facing northeast from the existing track; viewpoint 1

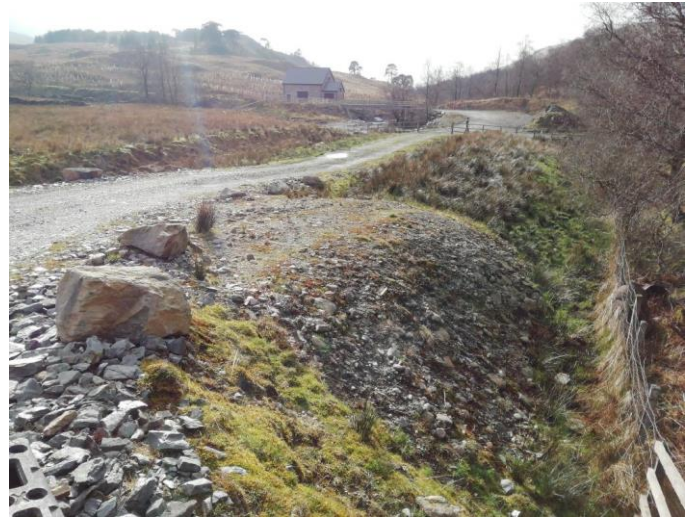
Figure 18. Upper Falloch: facing southwest, shows sparsely revegetating. In the middle distance, water pooling is evident, resulting in gravel bleeding into the far verge due to runoff; viewpoint 6

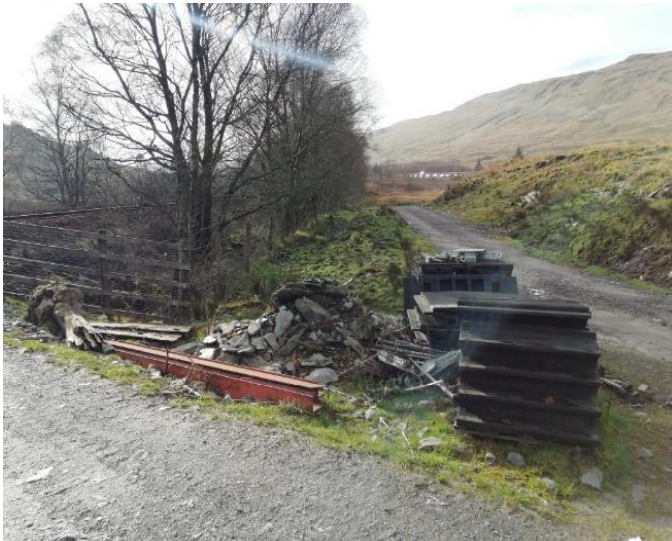
- Construction materials and debris were left beside the track on either side of the railway line (Figure 19). It is unknown if these were related to the hydro scheme, railway, or other works. Again, these were shielded from the railway line by trees and from the road and carpark by landform. Although possible, it is assumed walkers are unlikely to use this section of the track given it is further away from parking facilities than the railway underpass.

Figure 19. Upper Falloch: view from the northern side of the railway line. It is unknown if debris is related to hydro scheme, rail works or other; viewpoint 8

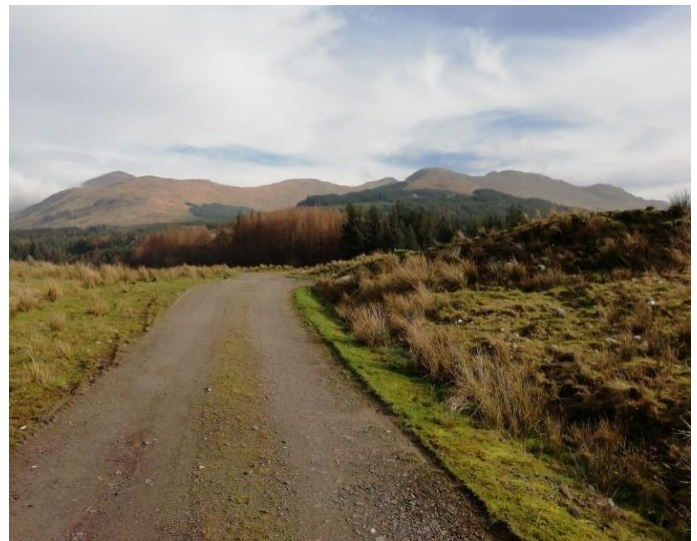
- As the track loops round the borrow pit to the carpark, verges were predominantly neat with only some disturbance from tyre tracks; despite this, vegetation was observed to be re-establishing (viewpoints 9 and 10). Early development of a central strip was evident at points along this section (Figure 20). The borrow pit itself now resembles hummocks and is well vegetated (viewpoint 10 and 11).

Figure 20. Upper Falloch: perpendicular to the A82, track verges are neat and central vegetation is evident. Former borrow pit on the right has vegetated well and resembles hummocks; viewpoint 10
